Navajo Abandoned Uranium Mine

Site Screen Report

Mesa V Mine AUM Site

Navajo AUM Northern Region

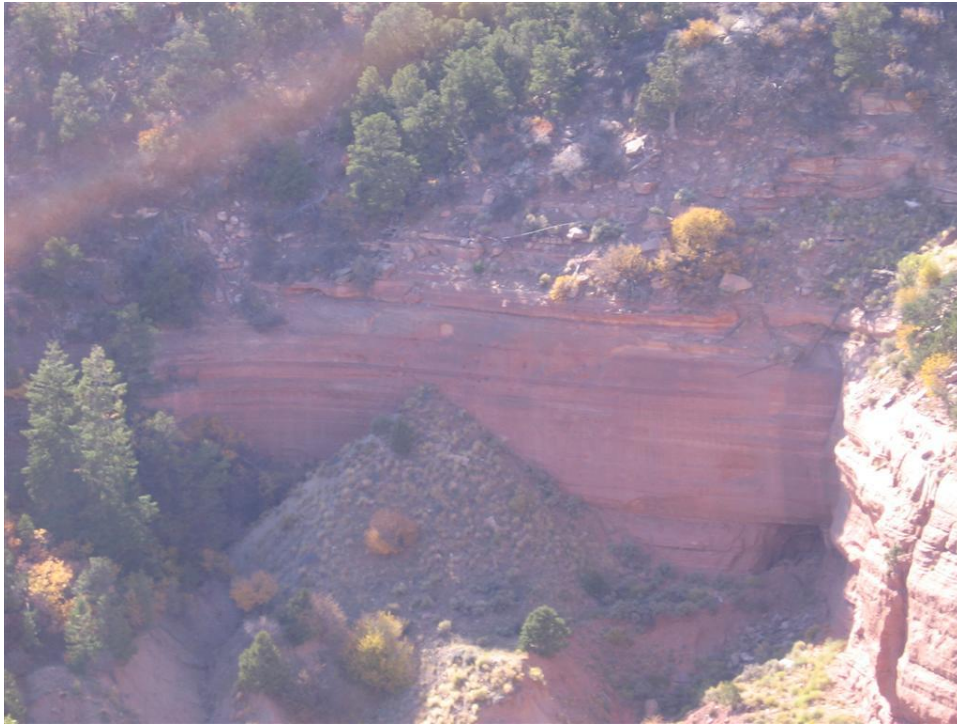
Waste debris extending down inaccessible cliff face, 75' x 75' x 75' triangle, with a total estimated volume of 514 yd³

Photo 1. Mine site #103 inaccessible waste pile

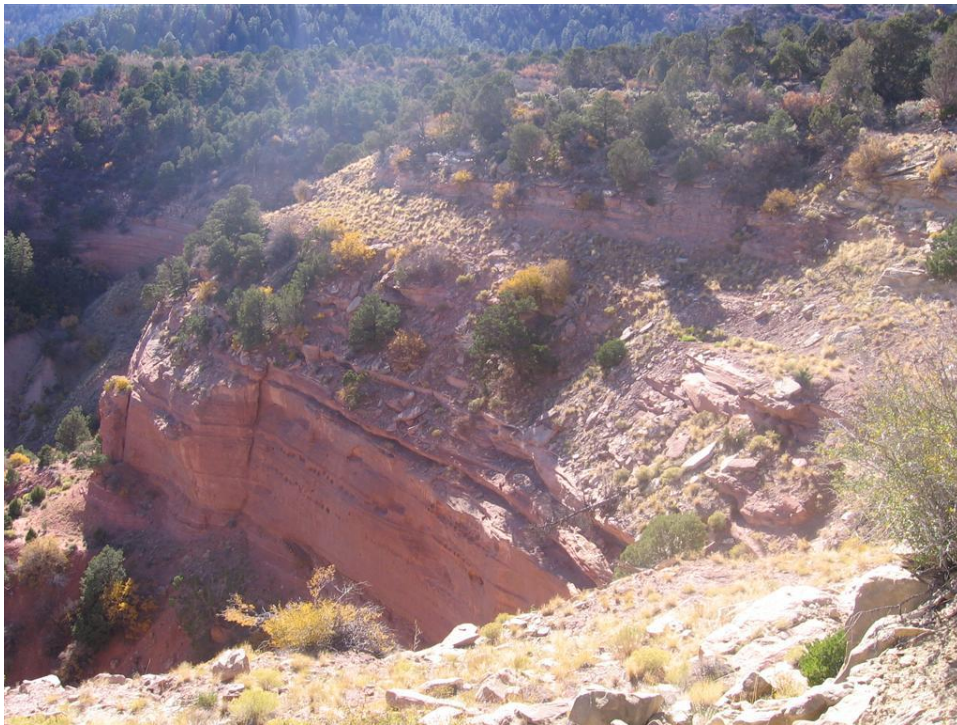
The majority of the site was inaccessible due to steep grades

Photo 2. Mine site #103 inaccessible area

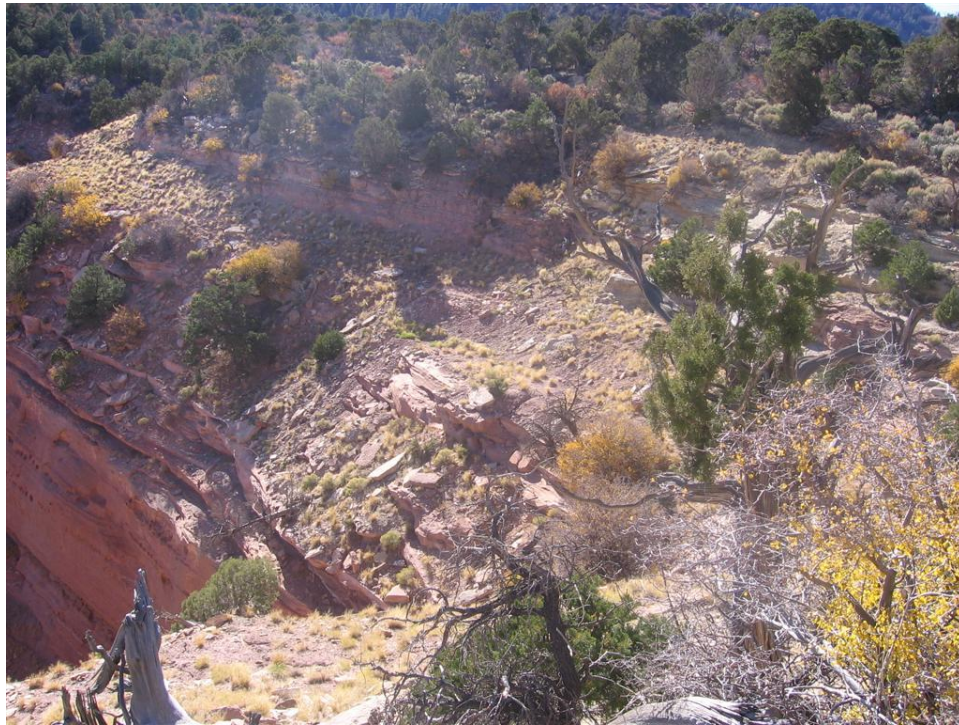
Photo 3. Mine site #103 steep grades

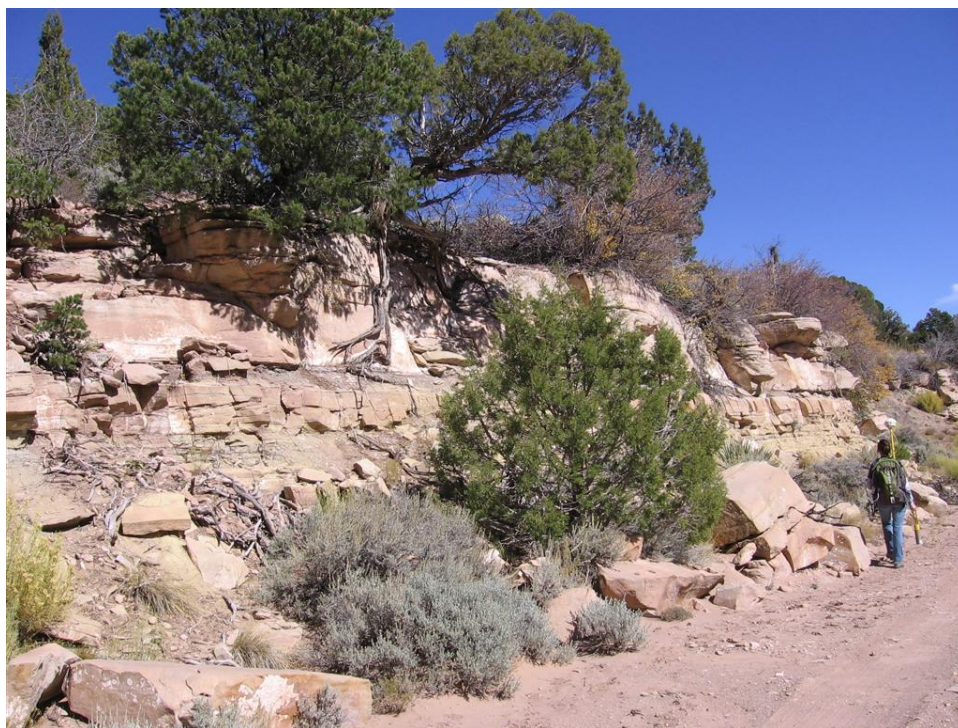
Photo 5. Mine site #508 access road

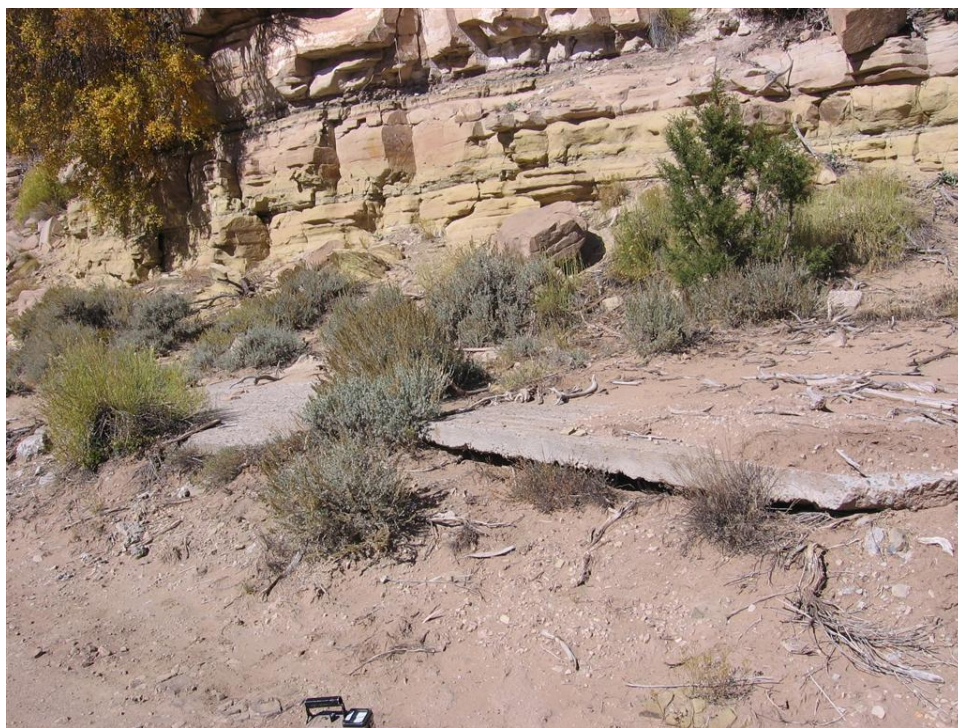
Concrete pads along the cliff face

Photo 6. Mine site #508 concrete pads

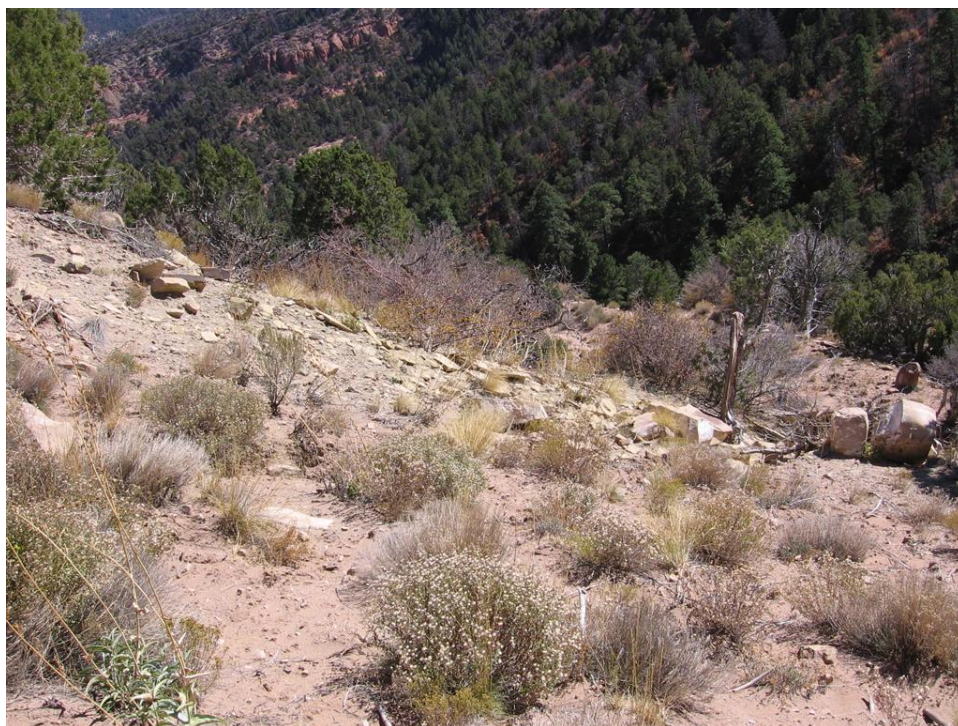
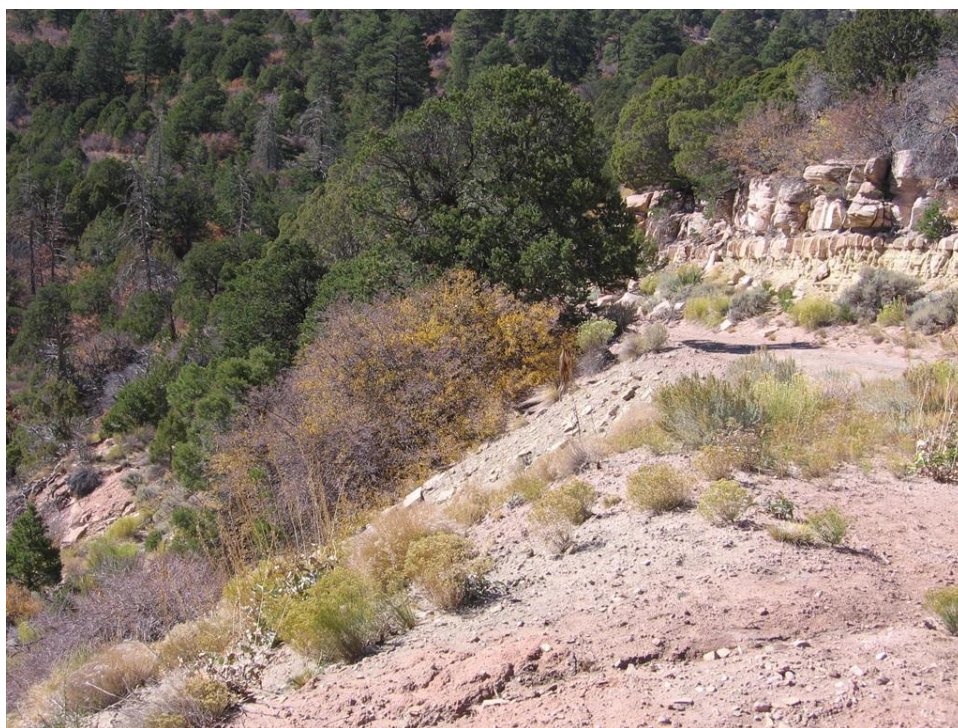
2 waste debris piles: 100' long x 50 - 60' tall waste debris along cliff face to the N-NW direction; 250' long waste rock pile and soft sand/clay stretching 25' down SE side of slope, with a total estimated volume of 2,083 yd³

Photo 7. Mine site #508 waste pile

Photo 8. Mine site #508 waste pile
